Technical Note N-1443

EVALUATION OF UTILITY EQUIPMENT FOR HARBOR OIL SPILL REMOVAL/RECOVERY SYSTEMS

Suresh C. Garg

June 1976

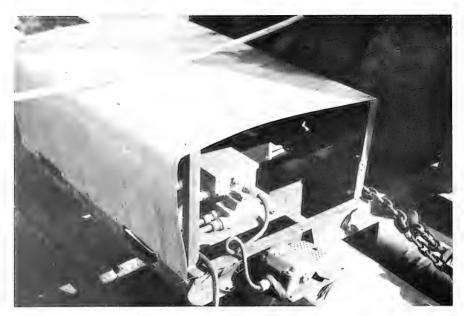
Figure 6. Emergency foot control of the PAU.

There were three difficulties noted in the PAU operation. First, the foot control, Figure 6, requires that it be pressed to stop the tires in an emergency. A more reasonable, and safer design would require that it be kept pressed during rotation of the tires. In the safer design, any emergency or operator distraction will cause the operator to step off the control thereby automatically stopping the tires from rotation. Second, there is no neutral gear to permit the tires to rotate freely during deployment of the boom. Therefore, physical removal of the drive chain was necessary for each boom deployment operation. This procedure is cumbersome, time consuming, and there is an ever present danger of losing the small chain parts during their installation and removal procedures. It is, therefore, recommended that the PAU be modified to permit free rotation of the tires to assist deployment of boom. Third, during operation of the PAU, the boom and the line from the boom kept getting stuck between the tires. This problem could be solved if the four tires are replaced by a long rubber coated cylinder.

- 1. The foot tire control mechanism should be rewired to require an operator to keep it pressed for tire rotation.
- 2. The PAU drive mechanism should be modified to allow free rotation of the tire during boom deployment without the necessity of removing the drive chain.
- 3. The boom retaining modification shown in Figures 1-5 should be attached on all PAUs to ensure that the boom remains on the tires during deployment and retrieval. However, the channel-iron used in this modification should be replaced by pipes to minimize the number of sharp edges.
- 4. The chute should be attached to all PAUs to reduce the risk of boom damage from pilings and protrusions on the pier. However, the angle irons used in the modification should be replaced by smooth pipes to minimize damage to the booms.

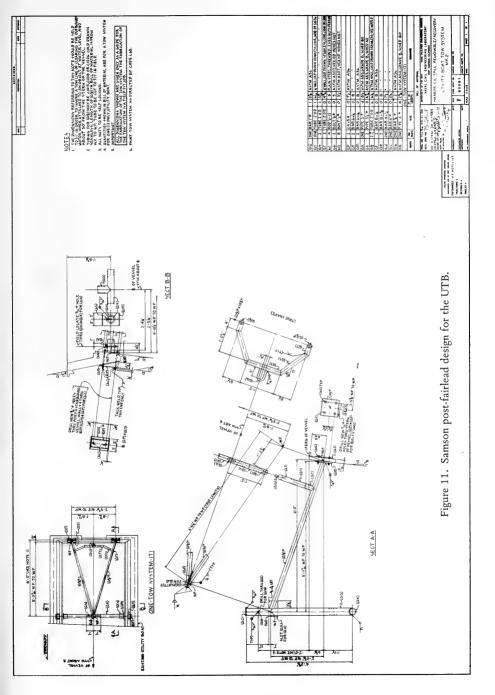
Samson Post: As recommended in reference 8, a samson post was installed in each of the two UTBs for towing, Figure 9. Straight line and catenary tows of boom were carried out using the UTBs with the tow line tied to the samson post, and also with the tow lines tied to the transom, to determine differences in maneuverability of the UTB. These tests confirmed findings of reference 8 that the maneuverability of the UTB was noticeably better when the tow line was attached to the samson post. However, the tests indicated two problem areas: (1) the height of the CEL designed post was such that when the boom was pulled on one side of the UTB, the tension in the line caused a sufficiently large turning moment to cause the boat to become unstable, and (2) the outboard engine was in the way of the tow line on occasions. A possible reason for the first problem was that the post was too high. A simple modification of the load carrying members of the samson post minimized both of the above possible problems. The modification consisted of installing a fairlead on the load carrying members of the samson post near the transom. Figure 10, high enough to clear the motor when it is raised to the stored position. The tow line from the samson post was then connected to the boom through the fairlead. This modification provided two benefits: (1) it lowered the effective tow point, and (2) the line was no longer in danger of hitting the engine.

It was felt, however, that the maneuverability and the stability of the UTB could be further enhanced if the samson tow point were lowered, the fairlead removed, and a guardrail installed as near the engine as possible to prevent the line from hitting the engine. The guardrail could only be lowered if it is moved further towards the engine so that it clears the engine completely. It is, therefore, recommended that a new design incorporating all these changes followed by test and evaluation of the effectiveness of the new design should be carried out. A conceptual illustration of the revised samson post-guardrail modification of the UTB is given in Figure 12.

- 1. A standard samson post-guardrail design should be developed and it should be incorporated in all present UTBs and all future UTB procurements.
- 2. Two fenders on both the port and the starboard sides of the UTB should be used to protect the UTB. Alternatively, bumpers recommended in reference 8 should be used.
- 3. Speedometers and/or tachometers are not necessary on the UTBs, and their use is not recommended.

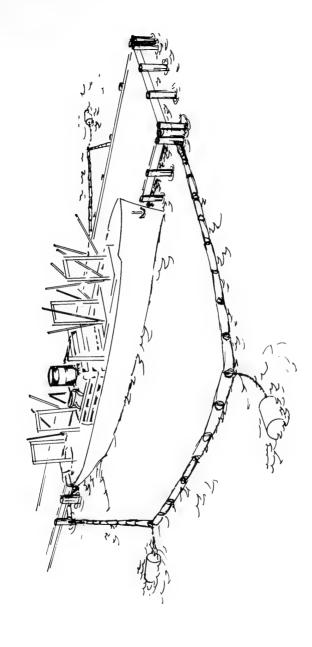
Figure 31. Mooring requirements for boom at an open pier - large ships.

To completely surround a ship berthed at a pier may require a minimum of three mooring systems if the ship is large and if the weather is adverse, Figure 31. Under calm conditions and for a smaller ship, two mooring systems may be adequate, Figure 32. In both cases, two pilings are also used for securing purposes. To completely contain a spill in an open area, four mooring systems are considered desirable if the winds and currents are variable, Figure 29. If winds and currents are
